Observations on different post-fire bio-engineering interventions and vegetation response in a *Pinus canariensis* C. Sm. forest

Published in:
Annals of Silvicultural Research

ABSTRACT On the Canary Islands, during the 2007 (30 July - 2 August) wildfire, about 18,000 hectares of forest were destroyed. After the event, to avoid erosion, a series of mixed check dams (wooden elements and stones with a core filled with forest residues) were built in the gullies created by the surface runoff. This first study aims to investigate the different responses of vegetation and its recovery after fire, with three different types of structures. We analyzed the performance and evolution of the mixed check dams nine years after their construction and the post-fire response of vegetation with the different types of bio-engineering techniques applied. The effects of the mixed check dams are expressed in terms of plant density, frequency, and cover both in absolute and in relative terms and the same effects were compared with those of the rocks, check dams, wattle fences, and structure in the surrounding areas. Our observations show that fire adaptation in the Canary Islands vegetation (pyrophyte p

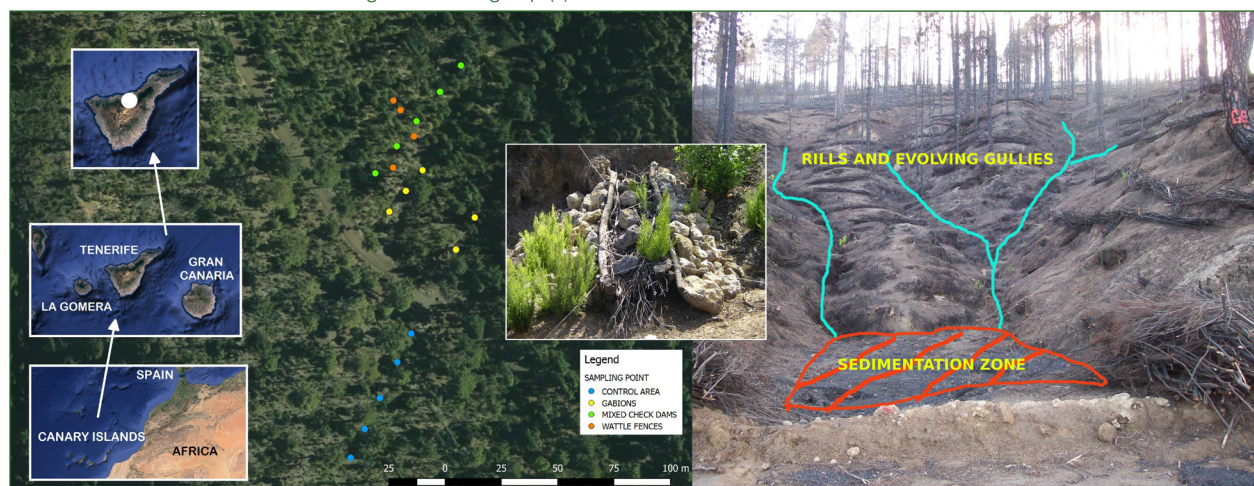
Figure 1 - Location of the sequences of survey points (a). Mixed check dam and wattle fences (b). The first storms after the fire carved a network of channels extending from the ridgetop (c).

High-severity fires have significant impacts on ecosystems. Commonly, the degree of fuel consumption in the understory or canopy layer (Perez and Moreno 1998) or the level of crown damage (Pausas et al. 2003) are considered, but the degree of mortality of trees and shrubs is also used to estimate fire severity (Chappell and Agee 1996). Fire modifies the soil protection provided by plants and consumes the soil surface organic layer (Neary et al. 2005a). High-severity fires may also burn the organic matter in the uppermost layer of the mineral soil, and the resulting loss of soil aggregates can greatly increase the soil erodibility (DeBano et al. 2005). Fires can also induce formation of a water-repellent layer on or near the soil surface (DeBano 2000). The consequences of the latter are low infiltration rates and high overland flow velocities which, in turn, increase the size of peak flows and surface erosion rates by sheetwash, rill, and channel erosion (Shakesby and Doerr 2006). Rills and gullies readily form where there is a surface runoff buildup caused by topography, rocks or logs (Fig. 1c).

Knowing that bio-engineering works can decrease flow speed, increase ground roughness and trap sediments (Vennetier et al. 2014), structures such as mixed check dams and wattle fences were built (Tardío-Cerrillo and Caballero-Serrano 2009) during the post-fire emergency period. These were used as the main treatment to reduce ephemeral or small-order channels or gullies, in combination with complementing treatments such as rock dams and gabions dams in larger channels and road cuts (Fig. 1b).

The study area is located in the Teide Forestry Crown (Tenerife Island, Canary Islands, Spain), at the north-facing side of the island (Fig. 1a). Here, a wide variety of meso- and micro-climates can be found (Del Arco et al. 2006) under a different range of vegetation including grasses, shrubs and trees. The forest is a natural stand dominated by *Pinus canariensis* C. Sm, mixed with *Myrica faya* Aiton, *Cistus symphytifolius* Lam. and *Erica arborea* L.

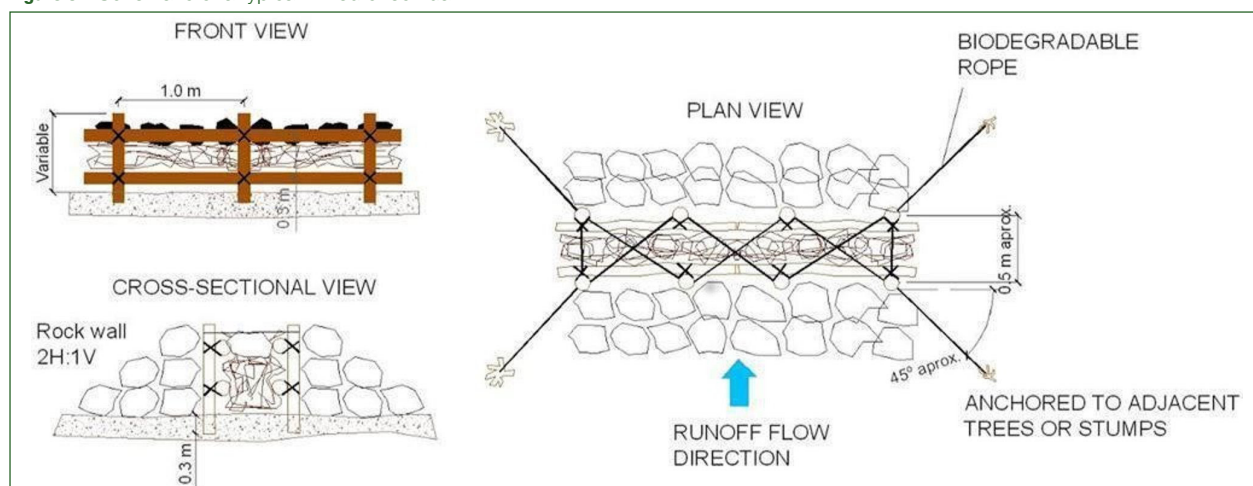
Figure 3 - Schematic of a typical mixed check dam.

In addition to the traditional channel treatments, an innovative structure adapted to local conditions called rock and biomass mixed check dam, was developed. Due to the severity of the wildfire and the resulting risks, the mixed check dam structure was designed to be low-cost, easily and rapidly implemented to reduce hydrological risks. The mixed check dam is a temporary structure that combines different mitigation techniques such as contour logs, contour trenches, and rock dams. Similarly, to other channel or gully treatments, its main objective and engineering function is to reduce the water velocity and enhance infiltration and sediment deposition. The mixed dam consists of vegetal debris used as vertical stakes (mainly burned logs of *Erica* sp. and *Myrica faya* Aiton), horizontal logs (mainly from burned *Pinus canariensis* C. Sm.), and biodegradable rope to tie the stakes and logs together as a trench while anchoring the whole structure to adjacent trees. The trench is reinforced on the outside by a rock slope (revetment) to gain stability (less than 50% slope angle); the inside is filled with vegetal debris obtained from the local silvicultural work and topped again

with rocks. The dimensions of a mixed dam vary depending on the channel width, ranging from 1 to 2 m in height and 8 to 10 m in length (Fig. 3).

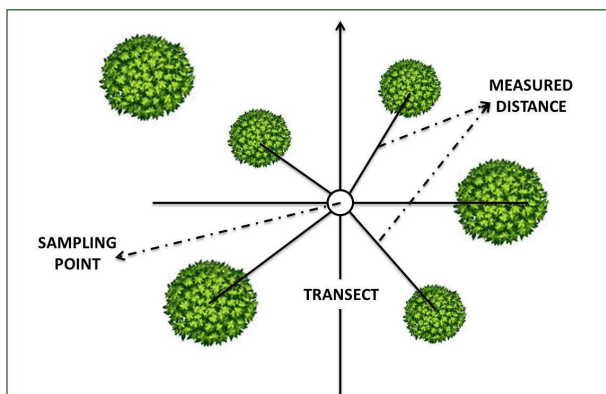
Figure 4 - Sampling design Point Centered Quarter measurements method.

The PCQ is a plot-less distance-based technique. Four quarters are established around a sampling point and four distances are measured from the point to the nearest element being analyzed. The parameters obtained in this distance method can be: species distribution, total and components density; average quantitative characteristics (diameter at

The lengths of the points sequences ranged between 80 and 100 m, with a limited number of survey positions considered for each treatment (5 for all other, 4 for 'wattle fences' sequence). Applying the PCQ approach, four distances, one for each quarter, were measured from the center to the nearest element of each vertical layer (Fig. 4) at each sampling point.

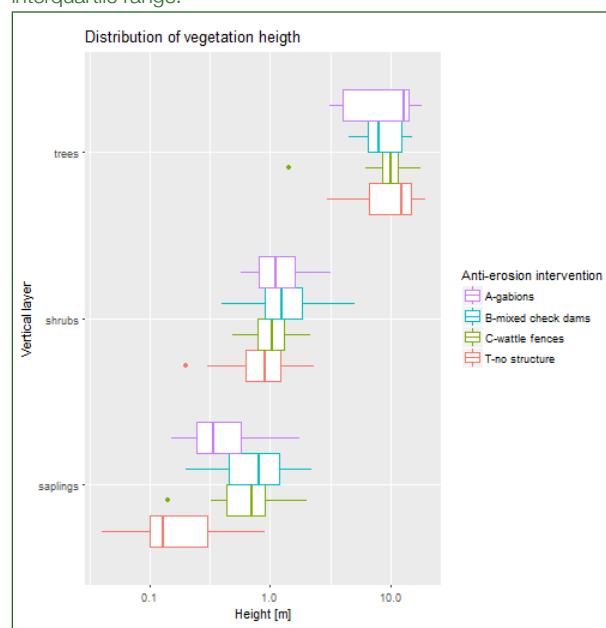
Figure 5 - Basic characteristics: distribution of vegetation heights, by anti-erosion intervention and vertical layer. Height scale is logarithmic. Boxes represent the first and third quartile, with the median in between as bold line, while whiskers are extended 1.5 times the interquartile range.

The three layers considered (saplings, shrubs and trees) are, as expected, vertically stacked and relatively similar, across treatments (Fig. 5), without relevant differences in term of height. Within each layer, heights distributions, syntetised by the box and whiskers, are relatively similar, except in the regeneration born in the controlled area which has low height values compared to the estimated regeneration in the other bioengineering structures.

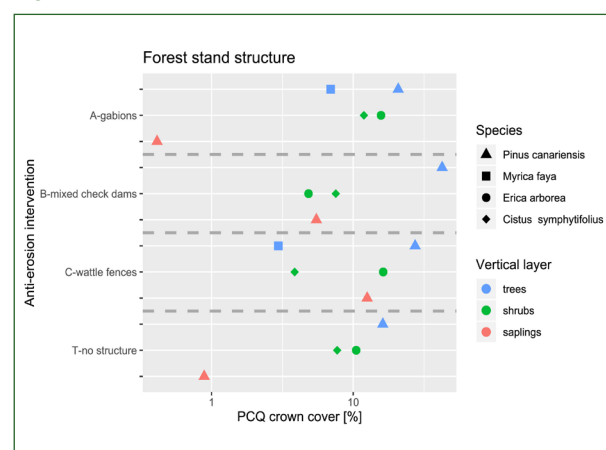
Figure 6 - PCQ estimate of total crown cover by species as percent (logarithmic scale) of the forest area.

res were built. The vegetation cover is assessed by multiplying the average crown area by the species density. This measure, expressed as percent of the terrain area, offers the most significant synthesis of the PCQ based survey (Fig. 6).

The analysis showed that *Pinus* trees always provide the most relevant coverage (reaching 42.5%) followed by *Erica arborea* L. Shrubs coverage is significant, though variable in terms of species composition while saplings present quite different coverage values. The presence of anti-erosion structures is associated with larger coverages by saplings of *Pinus canariensis* C. Sm.

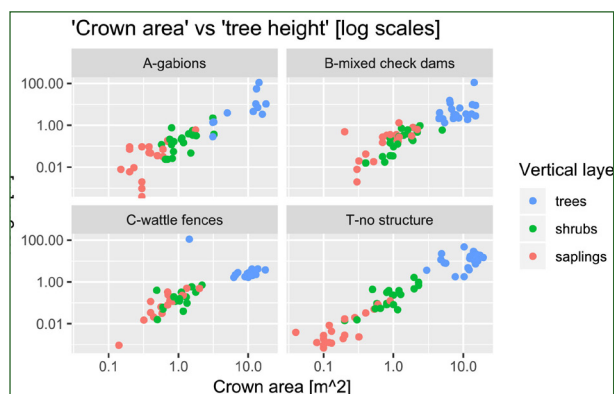
Figure 7 - Basic characteristics: height and crown area (logarithmic scales) are tightly correlated ($p < 0.001$), analyzed conditions present minor differences in values distributions.

The different attributes that were measured are quite tightly correlated (Fig. 6). Some minor diffe-

rences can be evidenced in the distribution of crown area versus element height. Crown dimensions appear to be reduced for trees in the 'wattle fences' area and for saplings in the 'no structure area'.
